Fuzzy Boundaries Between Post-Disaster Phases: The Case of L'Aquila, Italy

Diana Contreras¹

Published online: 19 September 2016

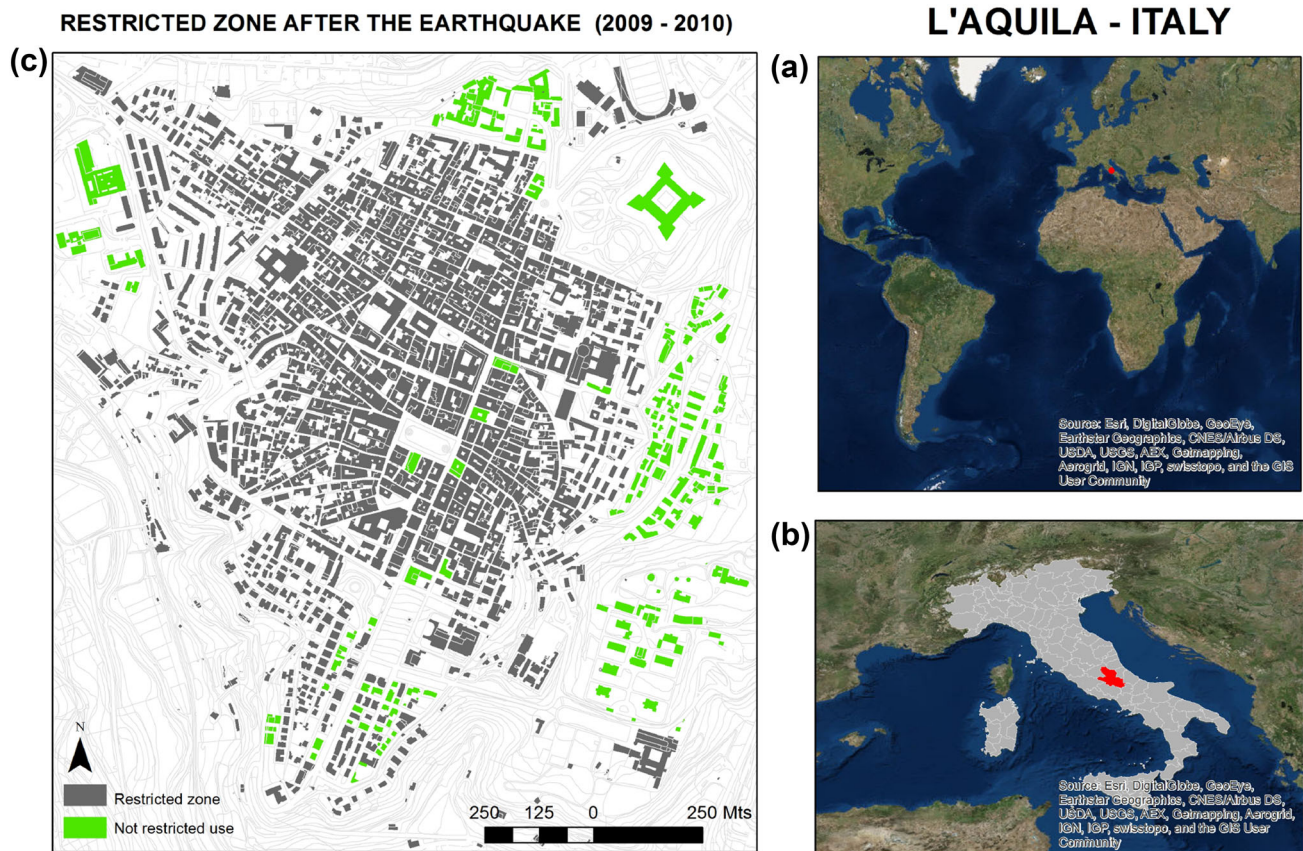
Fig. 1 a, b Location of the case study area: L'Aquila, Italy; c restricted zone in L'Aquila after the earthquake on 6 April 2009

On 6 April 2009 an earthquake with a magnitude of 6.3 M_W and a hypocentral depth of 10 km struck the Italian city of L'Aquila (population 72,800). The epicenter was located in Poggio del Roio, 3.4 km to the southwest of the L'Aquila city center. L'Aquila is the capital of the province by the same name, and the administrative capital of the Abruzzo region in central Italy. Its location is shown in Fig. 1a, b.

The historical city was badly damaged, 67,500 people were left homeless (Alexander 2010), 1500 people were injured (202 seriously), and 308 people lost their lives. About 10,000 buildings were damaged, and between 1.5 and 3 million tons of waste were generated (Brown et al. 2011). The cost of the damage was estimated at 16 billion Euros (UNIFI 2009). Due to the extensive damage the city center was cordoned-off and declared as restricted zone until 2014, as it is depicted in Fig. 1c.

This activity entailed five steps: (1) selection of a sampling area: the restricted zone after the earthquake (Fig. 1c); (2) selection of the categories that compound the indicators in the physical and socioeconomic dimensions; (3) analysis of the progress of recovery using spatial indicators: changes in building use (residential, commercial, transport, recreation, religious, hospital, office, educational, industrial, sports, hotel, monument, and not inhabited) before 2009 and after the earthquake in 2010, 2012, 2014, and 2016 as well as changes in building condition (new buildings, construction ongoing, partially enabled, reconstructed, reconstruction ongoing, earthworks, reconstruction projected, repaired, debris removed, propped, inhabited, damaged, restricted use, and demolished) for the same years (Contreras et al. 2014; Contreras and Blaschke 2016); (4) combining of results with weights allocated by experts in disaster management, geoinformatics, and remote sensing to the key spatial categories and indicators in a recovery index; and (5) determining the hotspots of recovery in L'Aquila based on the building use and building condition of the buildings in the time of the fieldwork and their contribution to the recovery process

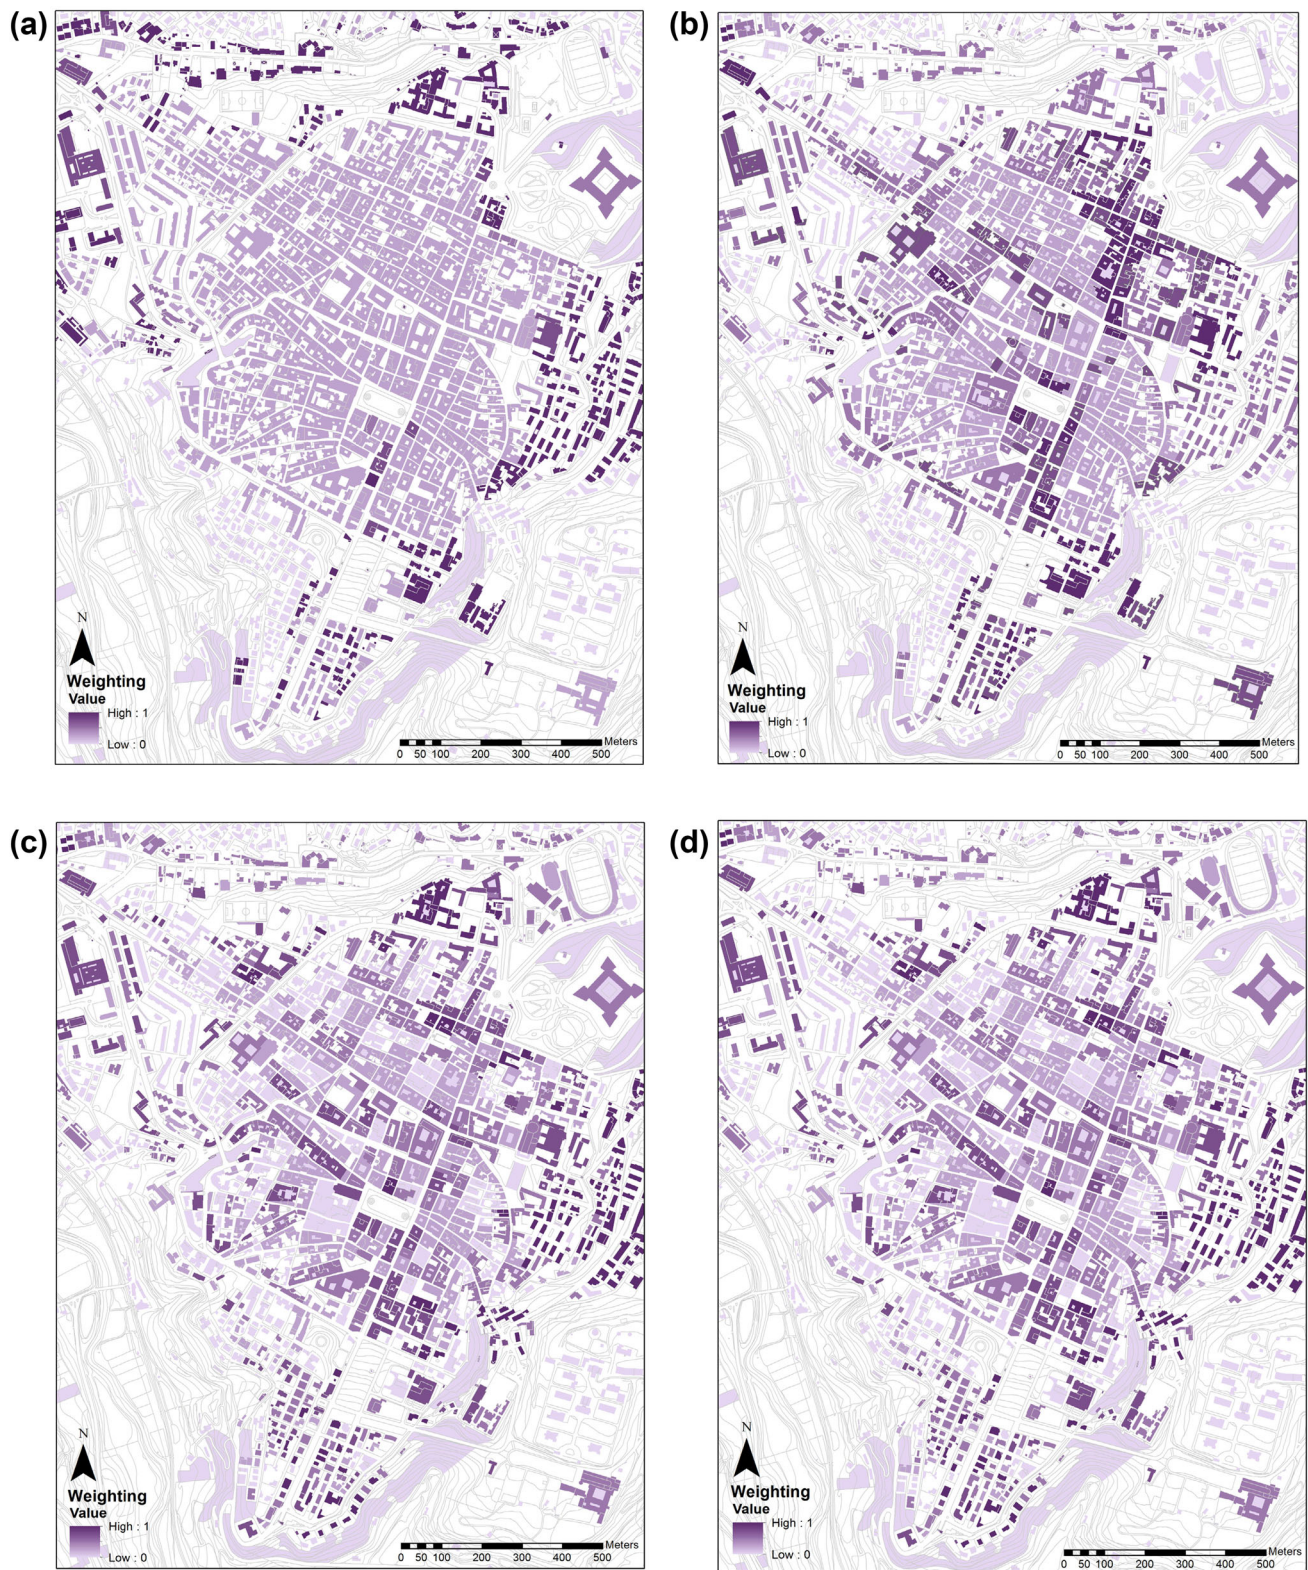
Fig. 3 Hotspots of recovery in the city center of L'Aquila, Italy after the 6 April 2009 earthquake in **a** 2010; **b** 2012; **c** 2014; and **d** 2016. *Source* Adapted from Contreras et al. (2016)

according to the experts. Building use before the earthquake is based on the observation of the announcements above the door of the stores and the photographs taken during the fieldwork, Google Maps, as well as information extracted from photographs available in the 3D model of the city of L'Aquila in Google Earth. The hotspots of recovery in the city center of L'Aquila in 2010, 2012, 2014, and 2016 are depicted in Fig. 3.

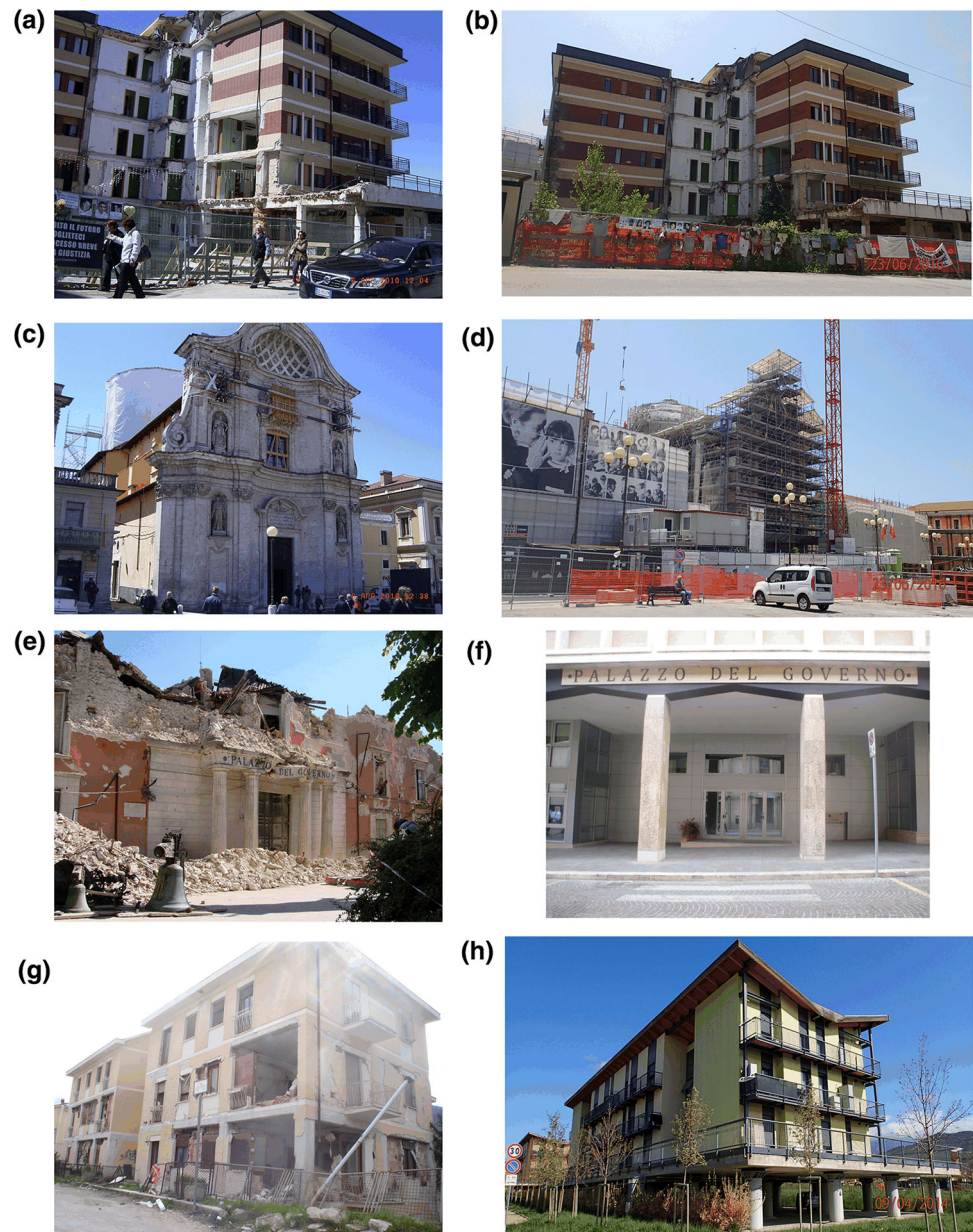
Fig. 4 Progress of rebuilding in L'Aquila, Italy, after the 6 April 2009 earthquake: **a** Students' dormitory along via XX Settembre in 2010 (one year after the earthquake); **b** Students' dormitory along via XX Settembre in 2016 (seven years after the earthquake); **c** Church Santa Maria del Sufragio in 2010; **d** Church Santa Maria del Sufragio in 2016; **e** Government Palace in 2009 (Photograph by David Alexander); **f** Government Palace relocated (2014); **g** damaged houses in the city center (2014); **h** new houses in Paganica (2014). Photographs by D. Contreras

In 2016 it was still possible to find buildings and houses in L'Aquila that were in the same, or even worse, condition as immediately after the earthquake in 2009 (Fig. 4a, b, g). This is the reason to assign the value of "1" to the damaged buildings indicator in the relief phase. Other buildings had been demolished, repaired, reconstructed, or were undergoing reconstruction (Fig. 4c, d). Therefore a value of "1" was assigned to the repaired houses/buildings reconstructed indicator for the early recovery and recovery phases. While the Government Palace in the city center of L'Aquila (Fig. 4e) had been relocated (Fig. 4f), damaged houses in the city center (Fig. 4g) had been reconstructed in new settlements in the outskirts of the city (Fig. 4h). In the sampling that included 753 buildings in the former restricted zone in the city center of L'Aquila, 163 buildings (22 % of the buildings considered in the sampling area) had been reconstructed by 2016, an encouraging sign of recovery in the city, taking into account that there was no

The Government Palace in L'Aquila (Fig. 4e, f) was relocated and reconstructed. The Castello (or *Forte Spagnolo*) was reopened in 2010, which encouraged the recovery of the city. The Basilica di San Bernardino opened in 2016. Other churches such as the Francesco Di Paola church still required structural support but were open to parishioners. Some churches, such as Santa María del Suffragio in the main square, continued with reconstruction work while remaining open for religious services. Others had been completely repaired by 2014, such as the Cattedrale Metropolitana dei Santi Massimo e Giorgio and the Basilica Santa Maria di Collemaggio. In 2016, the memory chapel next to the church Santa Maria di Collemaggio opened to visitors. This demonstrates that while some buildings give the impression that the development phase

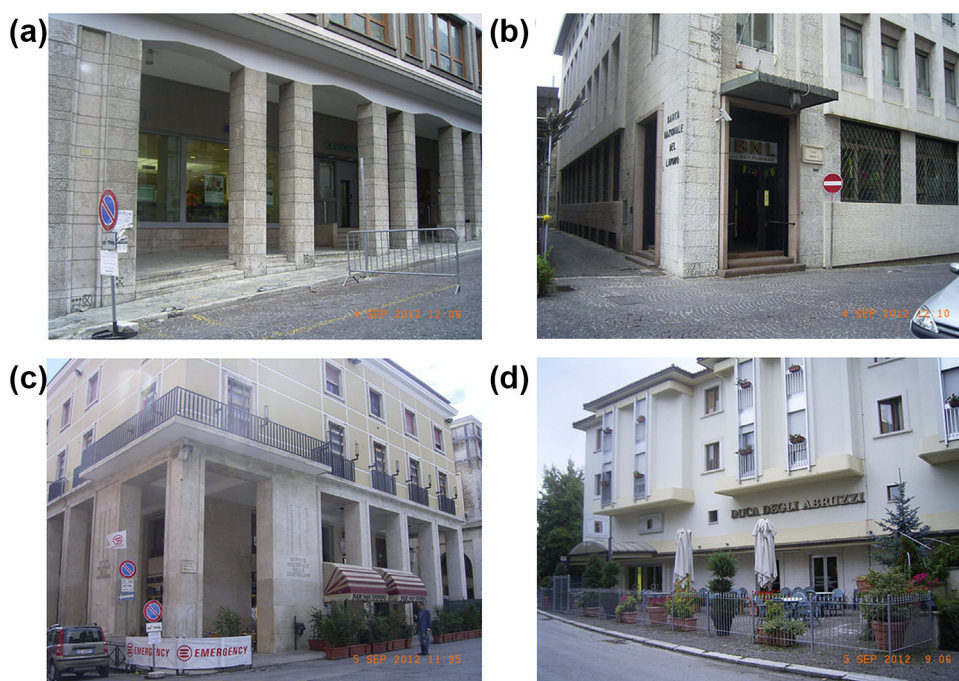
Fig. 5 Progress of rebuilding in L'Aquila, Italy, after the 6 April 2009 earthquake: **a** Savings Bank of Chieti—Carichieti—Agency of L'Aquila in 2012, 3 years after the earthquake (*Cassa Di Risparmio Della Provincia Di Chieti—Carichieti—Agenzia Di L'Aquila*); **b** National Bank of Business in 2012 (*Banca Nazionale del Lavoro*); **c** National Institute of Insurance in 2012 (*Istituto Nazionale delle Assicurazioni*); **d** Hotel Duca Degli Abruzzi in 2012 Photographs by D. Contreras

Only two banks (Fig. 5a, b), one insurance institution (Fig. 5c), and four hotels (Fig. 5d) had opened in the city center by 2016. Most restaurants in the city center had already reopened by 2012 and are located along the main road (*Corso Federico II*) or close to the main square (*Piazza del Duomo*). Some of the restaurants that had reopened were closed again by 2014, possibly due to the reconstruction activities that made access for pedestrians difficult and unsafe. This lack of stability in the opening and closing of commercial facilities shows the fuzzy boundary between recovery phases, in this case between the early recovery and the recovery. While in 2012 the city center started to be functional, more work in 2016 necessitated the closure of some commercial facilities, setting this zone back to the early recovery phase.
